城市轨道交通车辆转向架一系钢弹簧 疲劳断裂应力研究

摘要 [目的]城市轨道交通车辆转向架大多采用转臂定位结构。该结构下的一系钢弹簧常发生断裂问题,断裂区域多发生在与支撑圈接触的第一工作圈。导致钢弹簧断裂的影响因素较多,需要对此进行深入分析。[方法]结合车辆实际运用情况,优化了钢弹簧应力的计算方法,以具体项目设计参数为输入,评估了钢弹簧在考虑横向载荷后的应力水平情况,并计算其应力占比。选取某项目转向架一系钢弹簧组进行台架试验研究,描述了台架试验的设备及工装,一系内外螺旋钢弹簧贴片布置,以及试验加载及数据分析等情况。分析了B组内圈弹簧的应力测试结果,并以某测点在转臂侧的受力情况为例,分析了车辆采用转臂定位结构时钢弹簧的运用工况,重点分析了转臂转动对钢弹簧不同位置处所受应力的影响。最后从改善弹簧疲劳应力及接触线控制2个方面,对弹簧疲劳断裂的应对措施提出了建议。[结果及结论]此类弹簧疲劳断裂并非由于设计裕量不足引起,而是在制造过程中存在夹砂、聚粉及人工修磨不当等问题,导致接触线不连续,钢弹簧发生了应力集中。

Stress Analysis of Fatigue Fracture in Primary Steel Springs for Urban Rail Transit Vehicle Bogies

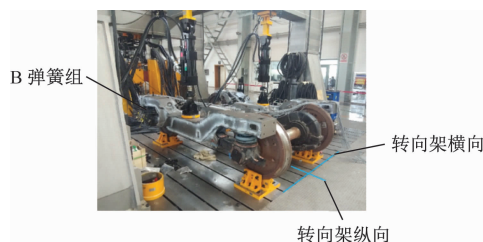
图 1 试验设备及工装

选取某车辆项目转向架一系钢弹簧组进行台架试验^[6-7]。为满足试验的加载需要,伺服激振控制器选取了 2 个载荷等级(15 t、10 t)的作动器,试验台及工装如图 1 所示,液压伺服系统如图 2 所示。

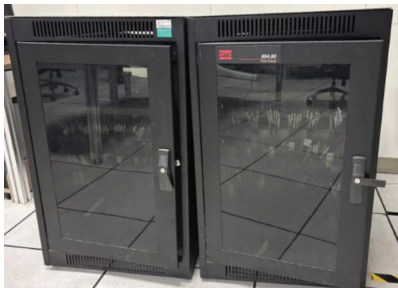
图 3 应变测量仪器

数据采集系统使用型号为 VTI1629 的应变测量仪,如图 3 所示。
